Study on How to Adapt Raw Clay Housing to Climate Change: Locust Bean Tree (*Parkia Biglobosa*) Used as Protecting Material

Samah Ouro-Djobo Eossoavana¹, Amey Kossi Bollanigni¹, Sanya Emile², Vianou Antoine² and Atcholi Eosso Kokou³

1. Building and Housing Centre, National High School of Engineers, University of Lomé, Lomé 20 564, Togo

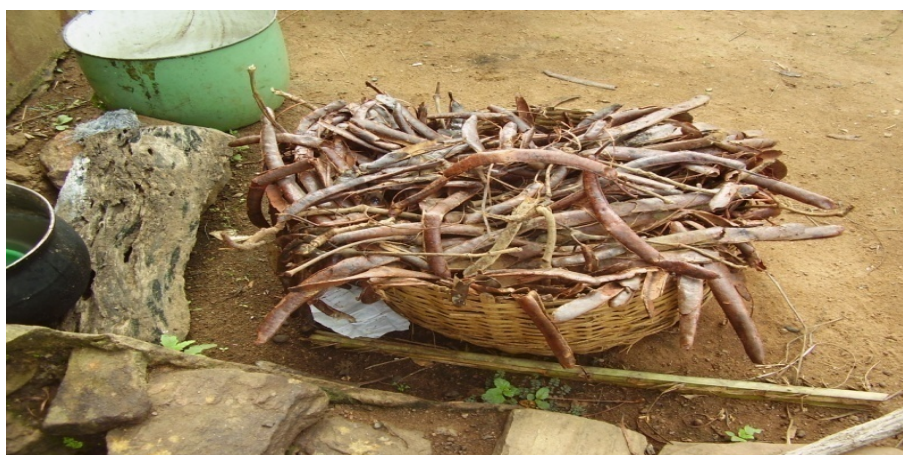
Fig. 1 Picture of locust bean tree (*Parkia biglobosa*) fruits' emptied husks.

- The pod-shaped locust bean mature fruits are gathered;
- The husks are freed from their grains (Fig. 1) then dried;
- The husks are then pounded, crashed and pulverised. Large amount of water is added to this powder (almost 7 L water/kg of powder). The mixture is then left to settle for at least 72 h (three days);
- Thereafter the husk extract is ready for use. It can thus be applied in two or three layers on the surface of the walls in question;

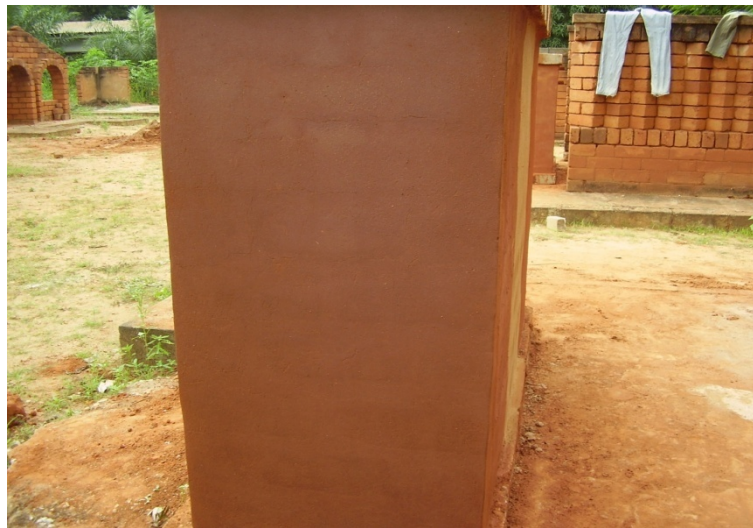
Fig. 2 Micro clay coating, sand and locust bean husk's extract.

coating, any coating applied in tiny layers, i.e., not exceeding 1 mm thickness. The composition of different types of tested coatings is as follows (from Figs. 2-5 in appendix):

- coating or micro coating made up of plain soil without any additive;
- coating or micro coating made up of three portions of sea sand, two portions of soil;
- coating or micro coating made up of three portions of sea sand for two portions of soil and one portion of cement.

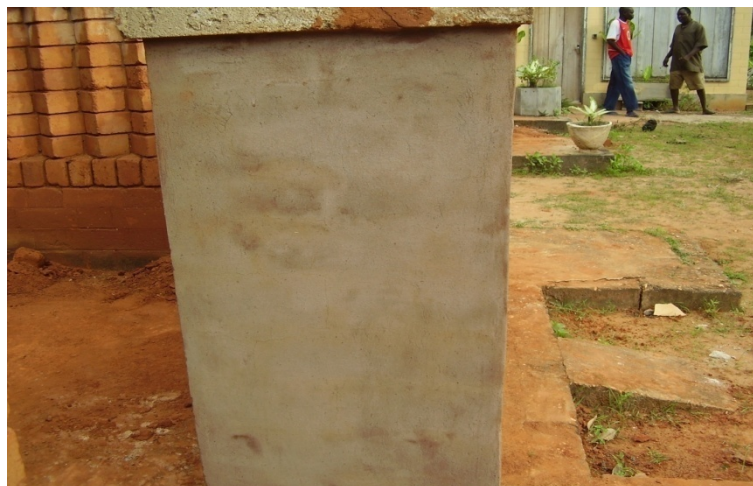
Fig. 3 Micro clay coating, sand, cement and locust bean fruit husk's extract.

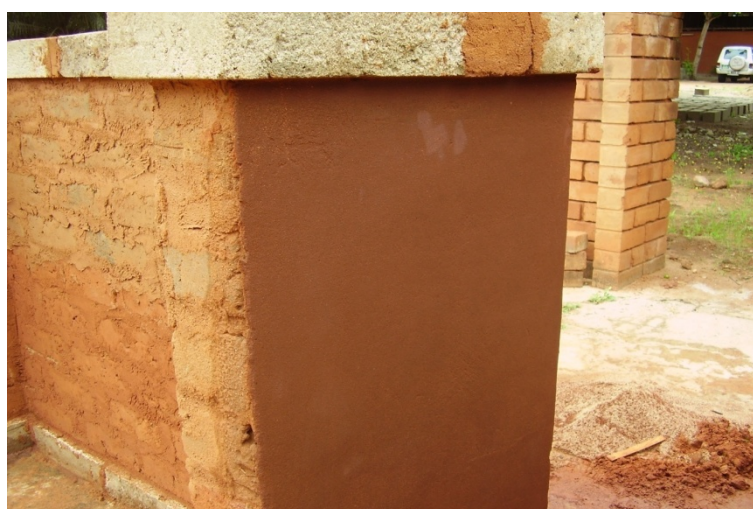
Fig. 4 Clay, sand and locust bean fruit husk's extract.

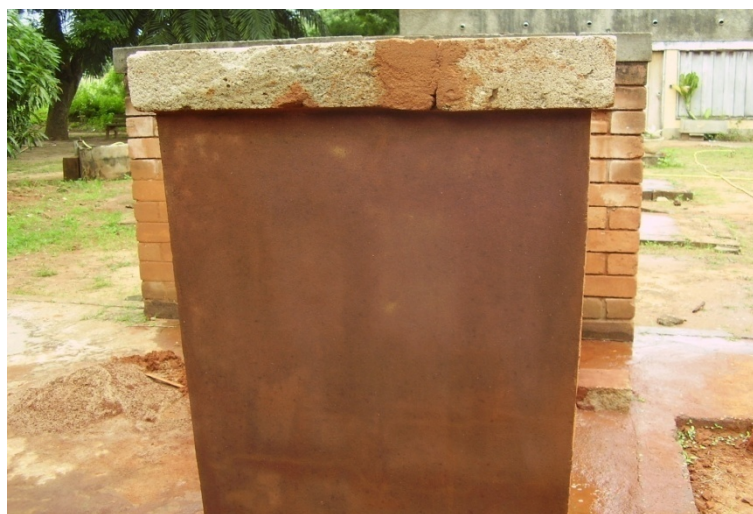
Fig. 5 Clay, sand, cement and locust bean fruit husk's extract.

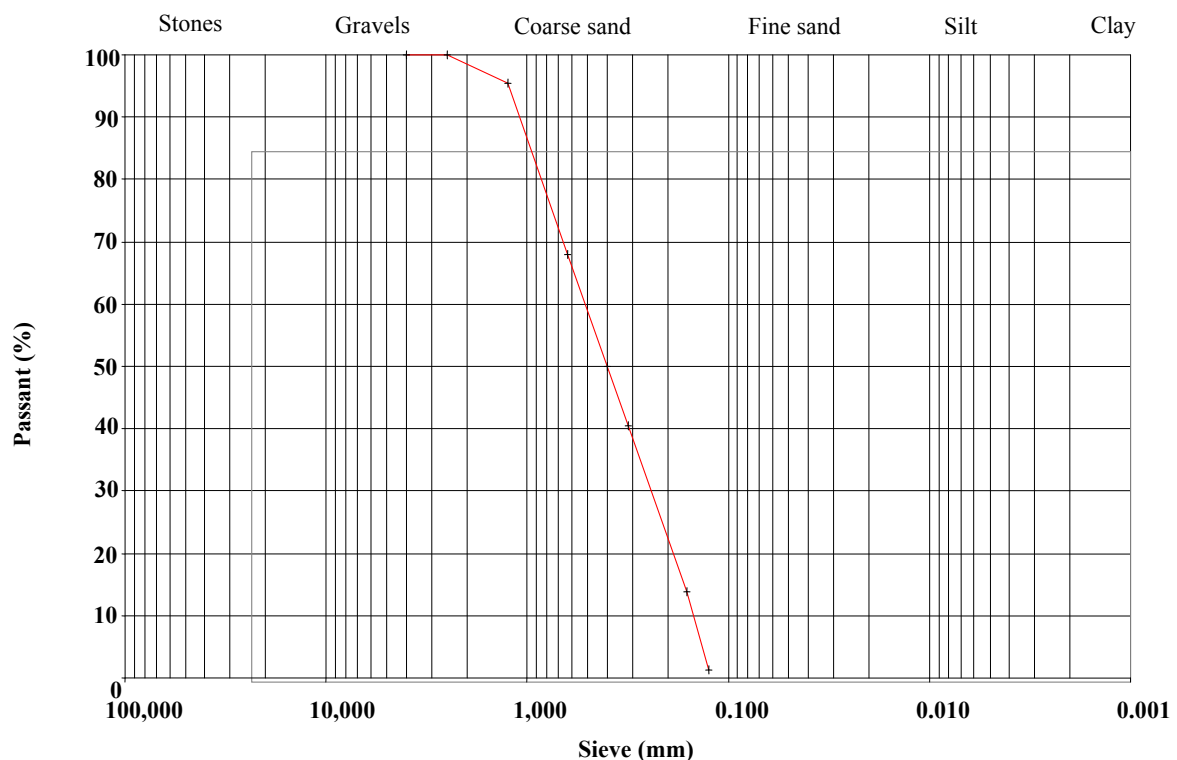
Fig. 6 Results of granular analysis of the Cacaveli soil sample.

The outcomes of the two types of analysis are set out in Figs. 6 and 7.

Fig. 6 shows the example of the granular analysis of soil material extracted from Cacaveli site. These results confirm the values obtained in the determination of the basic components: A 40.44% fine grains for soil sample extracted from Cacaveli site, 46.62% of soil from Legbassito site. To give an insight, technical documents set a proportion of 8% to 30% fine grains [6-9]. This stresses the need to proceed to the right calibration of the two soil materials in question in order to lessen subsequent shrinkage of the mortars during drying process.

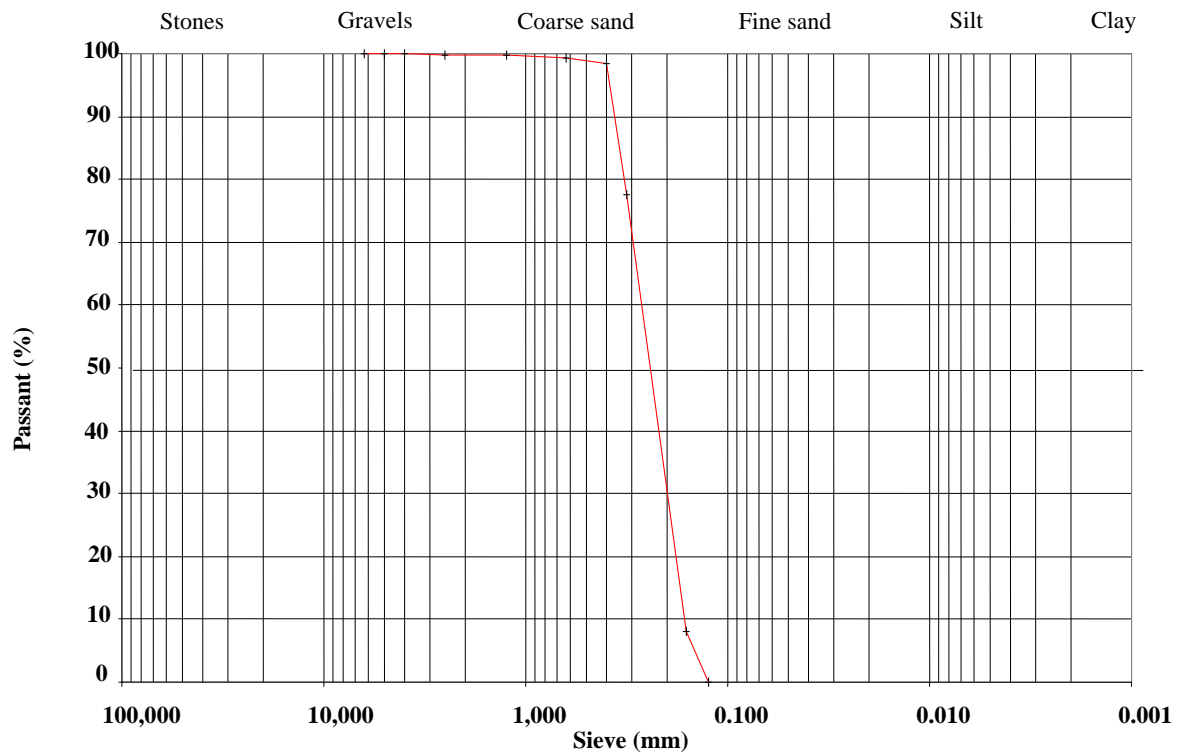
Fig. 7 Outcome of the sea sand granular analysis in question.

The results of the correcting sea sand grains analysis are set out in Fig. 7. They show that this sand is essentially made up of mid-sized and coarse grains with a very tiny portion of fine ones.

Those results enable to screen out suitable sizes of sea sand grains and convenient portions to fill the gap observed in above mentioned initial soils materials (i.e., from Cacaveli) in order to avoid their swelling and assure stability.
